Manhole Inspection Summary

Manhole # S35Q__060MH

Insp Date: **2/6/09 11:23 AM**

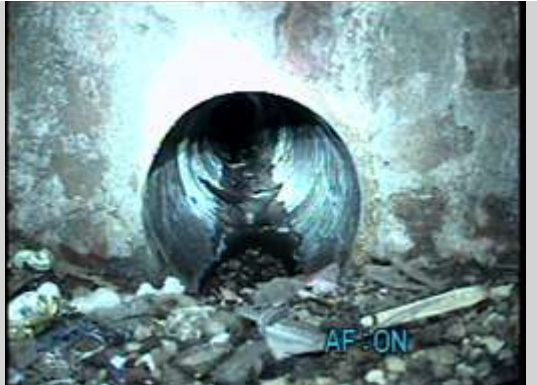
12 O'Clock Outflow

8 in. Circular Gravity Sewer
Pipe Out @ 12 O'Clock

Pipe Material: **Clay** ☐ Pipe Lined

Infiltration: **None** Pipe Seal Cond: **Unknown**
